Sunday, June 18 I met Bob Hedges at a farm on Oriole Mills Road, Rhinebeck. We took photographs and some measurements of the original stone house with frame extension. We registered the site:

One-room one-and-a-half story stone house with one-room 4-bent timber frame extension and second story sawn wood frame addition also summer kitchen and two barns with sawn frames

___/Davidge/Williams (NY/Dut/RH/25)
Red Hook, Dutchess County, NY
N41°58.279' W073°50.943' Elev. 548'

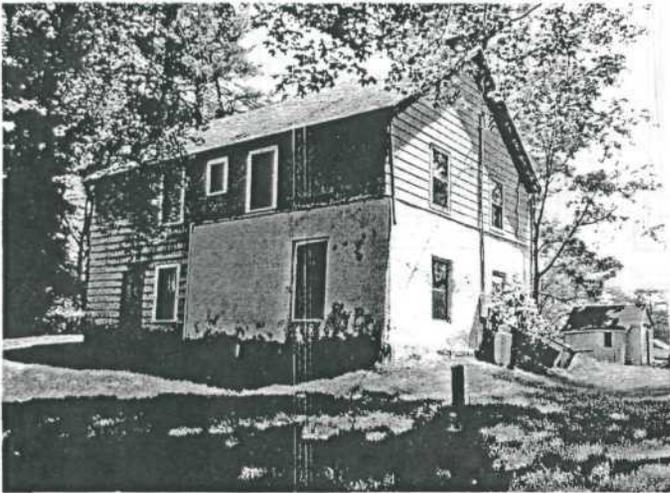
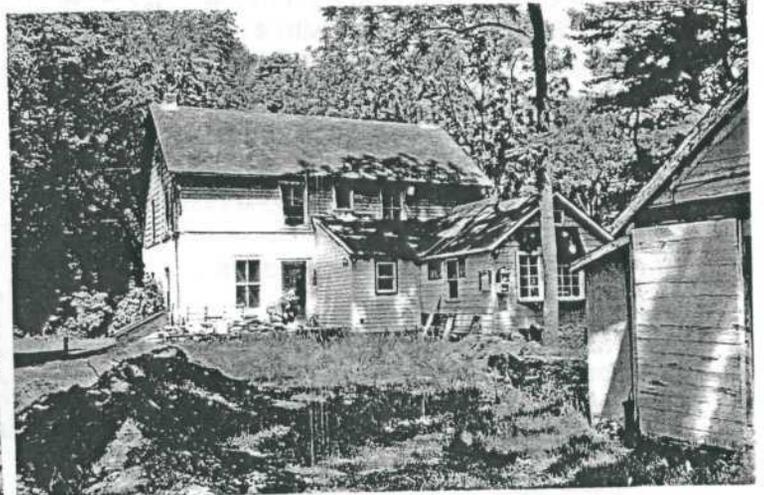
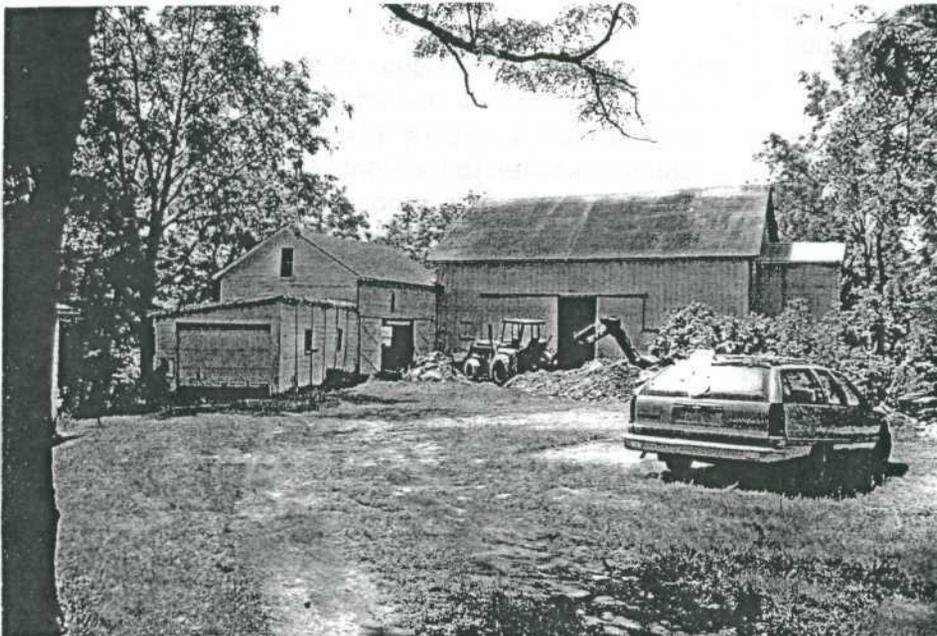
/Davidge/Williams House and Barns
Red Hook, Dutchess County, NY

The banked hay barn and carriage barn were built in the late 19th century with sawn timber frames. They are in good condition. The large barn is 3-bays with side entrance, basement, vertical board-and-batten siding and vertical purlin-posts. It has no hay track as hay was probably loaded from the main floor.
