Loft Casement Window
Pieter Bronck House, 17th century
West Coxsackie, Greene County, NY
photograph by Jim Decker

Two-room stone house with stone extension
DePuy/DeWitt/McBride (NY/Uls/War/09)
Wawarsing, Ulster County, NY
N41'45.840 W074'20.537 422-foot elevation

DePuy/DeWitt/McBride House (War/09)
Wawarsing, Ulster County, NY

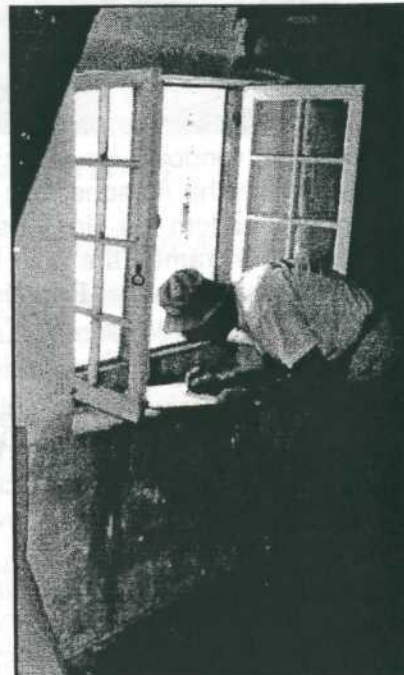
(right) John Stevens takes measurements.

There are gains, notches, in which one could attach thin horizontal wood bars. Their spacing corresponds with the 5-inch height of the glass. One guess was that they were another way to save iron by supporting the sheet of leaded glass not on the outside with a metal bar but inside with a wood bar, something like the English did it.

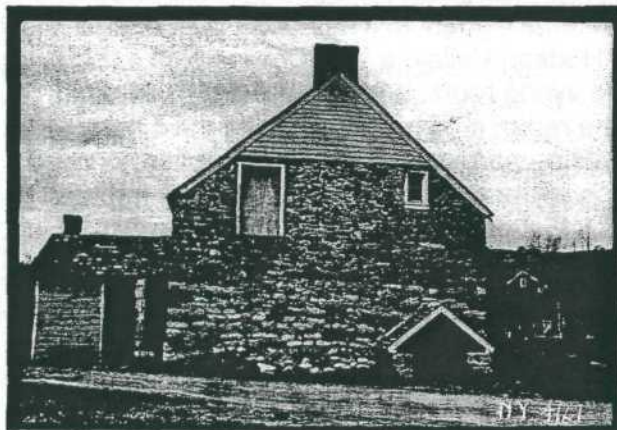
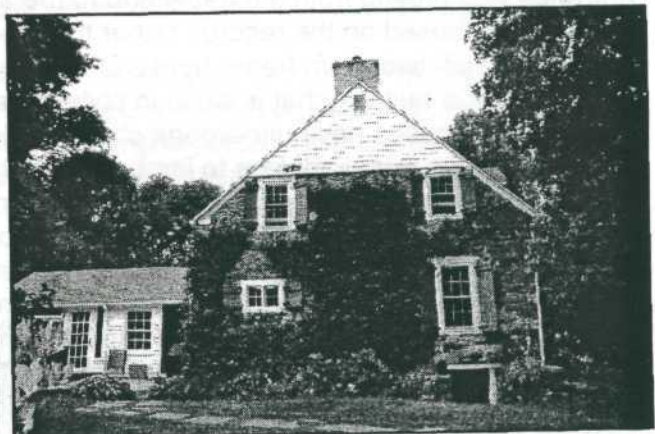
Evidence in the beam size and distribution indicate the house originally had Dutch jambless fireplaces on the end walls, dating it before 1760. The 3-bay stone extension shows no hearth evidence. One raised panel interior door with local hardware survives. The large chimney of the left end fireplace is built of stone before it exits the roof where it is finished with brick. This seems to indicate that the original smoke hood was built of the same small stones. The nearby two-room Bevier/Newkerk stone house (War-4), that was destroyed recently, had such a unique surviving stone smoke hood and these might be attributed to a lack of good local clay or availability of bricks in this frontier community.

(left) HABS photo 1930's. (right) photograph by Jim Decker, 2006
