DePuy/DeWitt/McBride House (War/09)
Wawarsing, Ulster County, NY

Two-and-a-half story center-hall stone-house with
back frame addition and stone summer kitchen
1830 Cantine/Warren House (Mar-31)
Stone Ridge, Town of Marbletown, Ulster County, NY

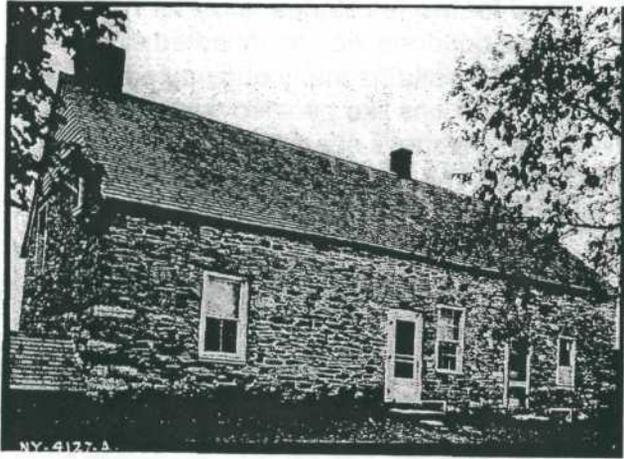
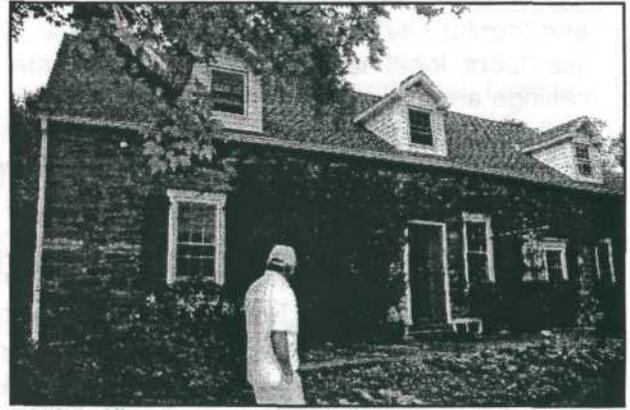
(left) HABS photo 1930's. (right) photograph by Jim Decker, 2006

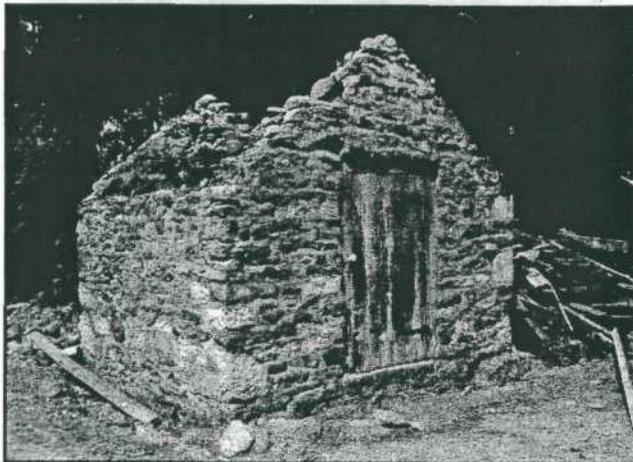
**Stone Summer Kitchen behind the
1830 Cantine/Warren House (Mar-31)**
Stone Ridge, Town of Marbletown
Ulster County, NY

There is said to have been an earlier frame house on this site that burned and the stone summer-kitchen behind the house could well be earlier. It has a miniature jambless fireplace and its smoke hood is built of stone. It has an iron trammel bar but its hood beam is rotten at one end and has fallen at an angle. It has allowed some of the hood to fall.

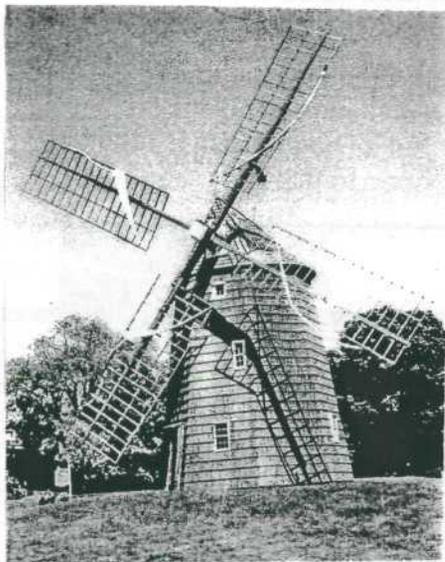
**Hook Windmill,
East Hampton, Long Island, NY**
Built 1806 to replace post-mill built in 1738. Central post of earlier mill re-used.
